Re: **Source Control Evaluation Addendum**
Phillips 66 Willbridge Terminal
Portland, Oregon

AECOM, on behalf of Phillips 66 Company (P66), is providing the Oregon Department of Environmental Quality (DEQ) this Source Control Evaluation Addendum for the Phillips 66 Willbridge Terminal (Site) located in Portland, Oregon (Figure 1). This addendum follows the ConocoPhillips Portland Terminal Source Control Evaluation Report prepared by Stantec during January 2011. The addendum summarizes additional source control investigation activities which were completed in accordance with the Sediment Sampling Work Plan submitted by AECOM in October 2014.

Photo Log

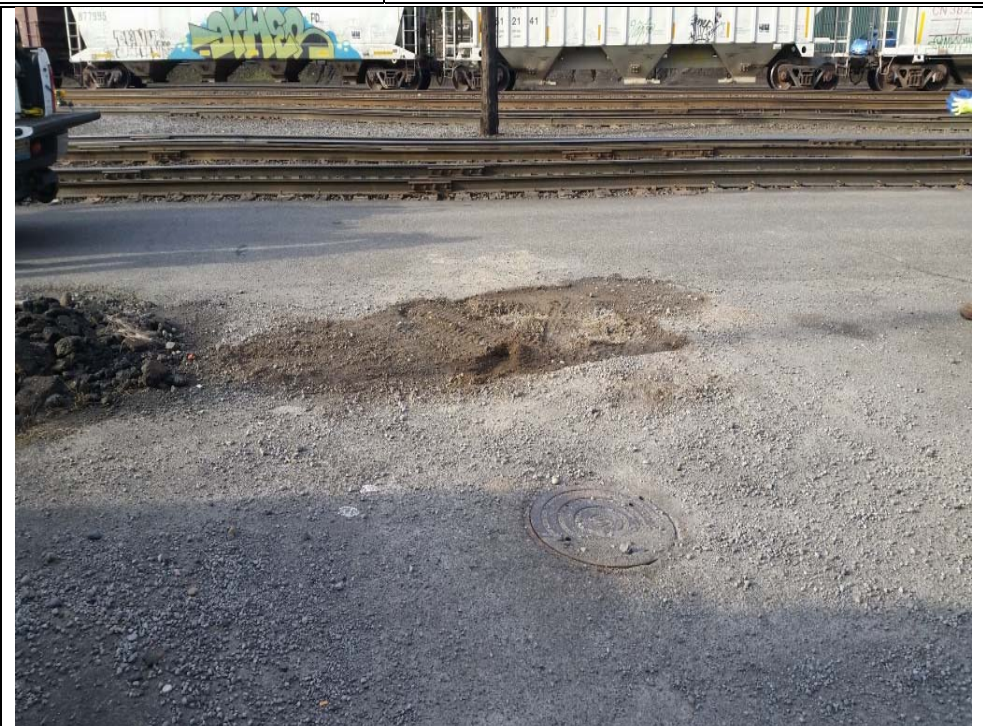
Client: Phillips 66	Project Number: 60285571.5625.03
Project Name: Portland Willbridge Terminal SCE	Site Location: Portland, OR
Photograph No.1

Photographer: M. Tauscher	
Date: 3/12/15	
<p>Direction Photo Taken: South</p> <p>Comments: Manhole MH-9 (foreground) and Manhole MH-11 on BNSF Willbridge property.</p> <p>MH-11 under gravel south of MH-9.</p>	
Photograph No.2

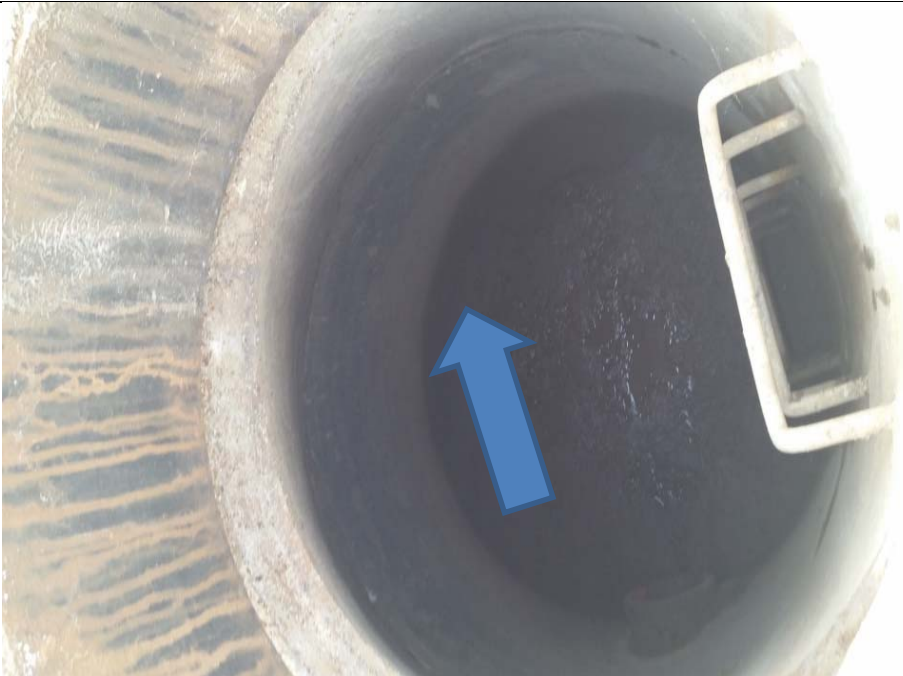
Photograph No. 3

Photographer: M. Tauscher	
Date: 3/12/15	
Direction Photo Taken: NA Comments: Manhole MH-9 total depth 7 ft. 2 inches. Blue arrow depicts flow direction.	
Photograph No. 4

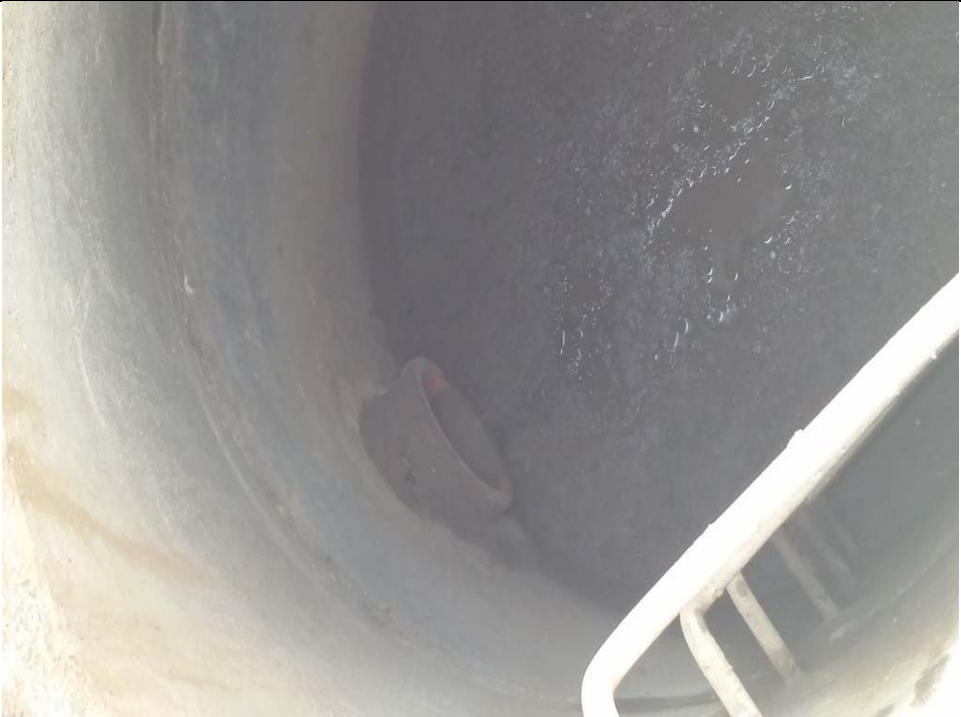
Photographer: M. Tauscher	
Date: 3/12/15	
Direction Photo Taken: NA Comments: Manhole MH-9 outlet.

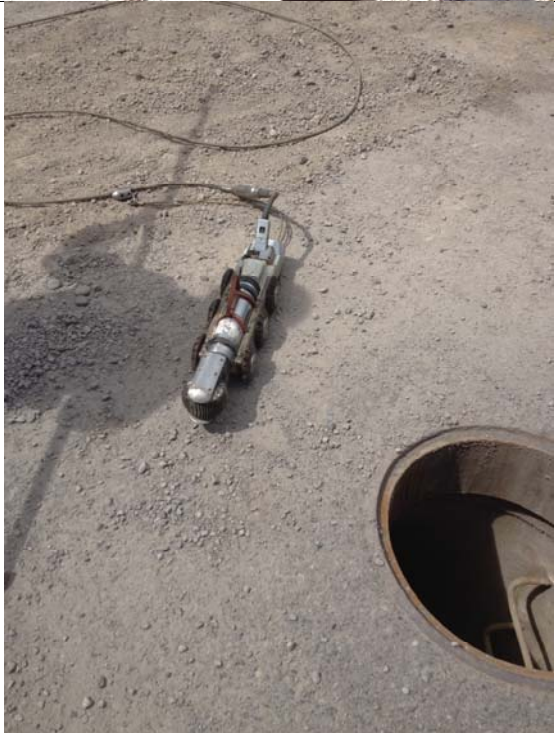
Client: Phillips 66		Project Number: 60285571.5625.03	
Project Name: Portland Willbridge Terminal SCE		Site Location: Portland, OR	
Photograph No. 9

infiltration were observed at approximately 56 feet, and 96.3 feet from MH-9 (See Appendix A, Photos 9 and 10, and Figure 2).

Photographer: APS			
Date: 6/23/15			
Direction Photo Taken: N/A			
Comments: Crack in the clay pipe between MH9 and Final Box #2 approximately 56 feet upgradient of MH-9. Visible signs of historic infiltration.			
Photograph No. 10

Based on the video survey of the 8-inch pipe between Final Box #2 and MH-9, a number of cracks, offset joints and areas of water infiltration were observed. At this time, Phillips 66 is evaluating options for a path forward. Once the plan has been developed, Phillips 66 will notify the ODEQ with the plan and schedule.

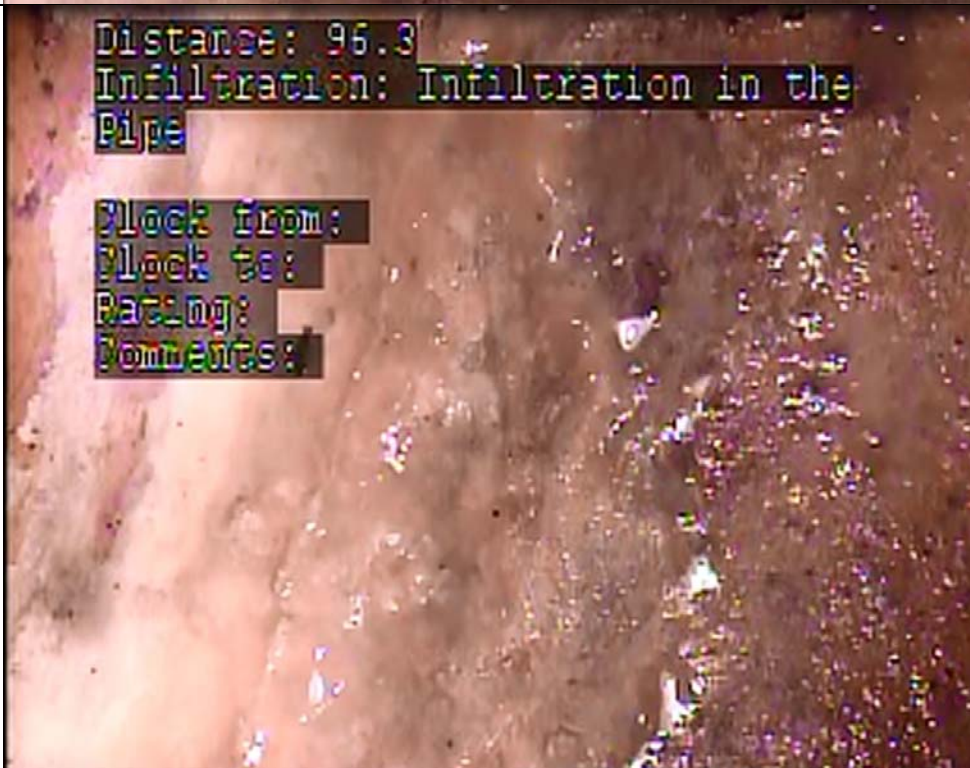
Numerous small cracks and fractures, and some large fractures were observed in the clay pipe section between MH-9 and Final Box #2 (See Appendix A, Photos 9 through 14, and Figure 2). Visible signs of

Photographer: APS			
Date: 6/23/15			
Direction Photo Taken: N/A			
Comments: Cracked clay pipe with an active infiltration weeper and mineralization approximately 96 feet upgradient of MH-9 between MH-9 and Final Box #2.

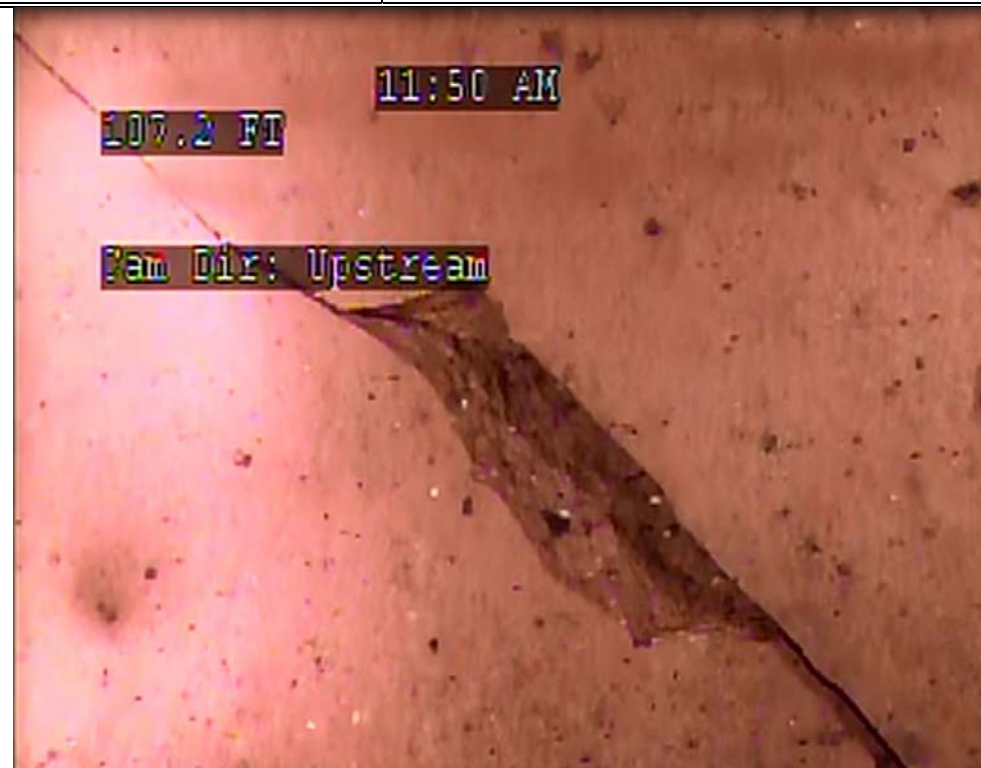
Client: Phillips 66	Project Number: 60285571.5625.03
Project Name: Portland Willbridge Terminal SCE	Site Location: Portland, OR
Photograph No. 11

Photographer: APS	
Date: 6/23/15	
Direction Photo Taken: N/A Comments: Part of a large fracture in the clay pipe approximately 107 feet upgradient of MH-9 between MH-9 and Final Box #2.	
Photograph No. 12

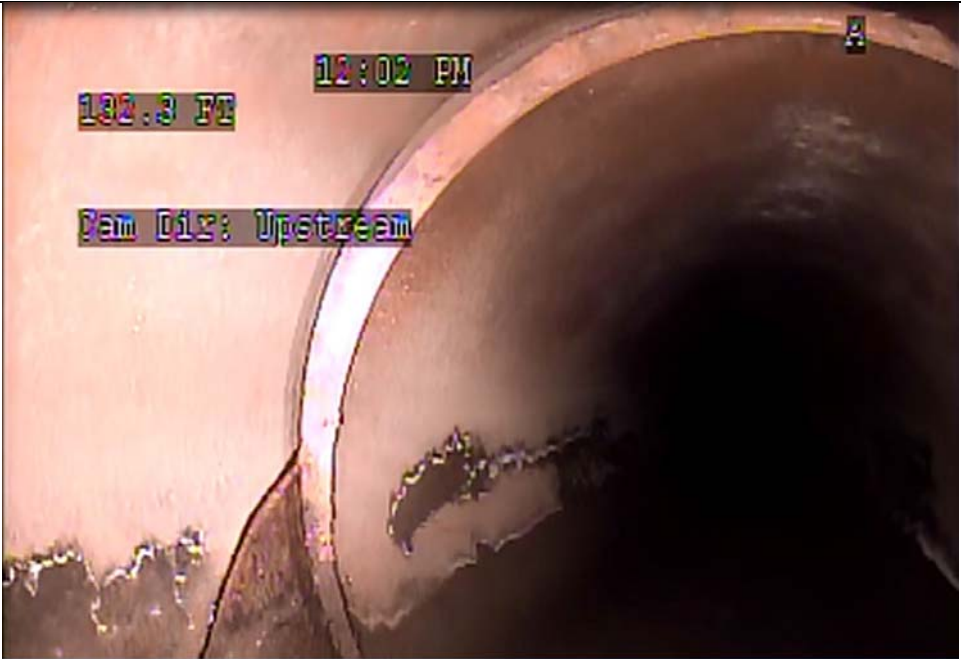
Client: Phillips 66		Project Number: 60285571.5625.03
Project Name: Portland Willbridge Terminal SCE		Site Location: Portland, OR
Photograph No. 13

Photographer: APS		
Date: 6/23/15		
Direction Photo Taken: Upgradient Comments: A large fracture and offset joint in the pipe between MH-9 and Final Box #2, approximately 132' upgradient of MH-9.		
Photograph No. 14

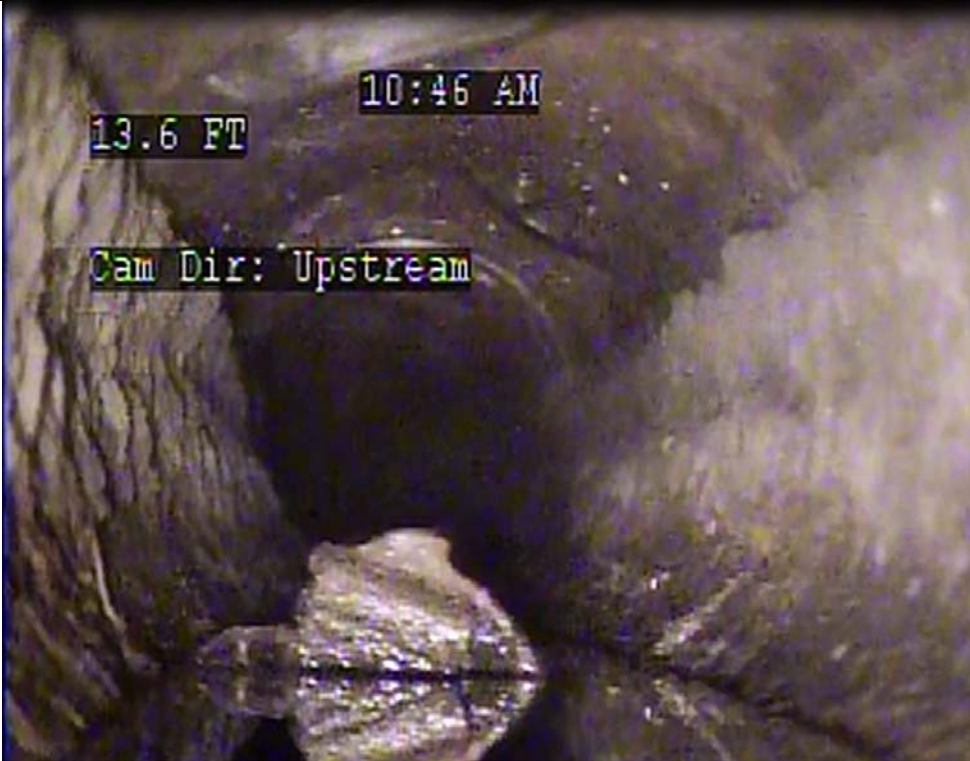
Client: Phillips 66	Project Number: 60285571.5625.03
Project Name: Portland Willbridge Terminal SCE	Site Location: Portland, OR
Photograph No. 17

Photographer: APS	
Date: 6/23/15	
Direction Photo Taken: Upgradient Comments: A large piece of debris in the pipe between MH-11 and the cleanout located in the rail car facility on Site. Photo was taken from the elbow approximately 13.5 feet upgradient from MH-11 where the remote camera could not make the turn. Heavy accumulation noted on the pipe.	
Photograph No. 18

The storm water pipes contain a number of cracks and offsets and in select areas, accumulated sediment. AECOM recommends that the 12-inch pipe between MH-11 and the roof drained be cleaned to further evaluate the condition. The accumulation of sediment is currently prohibiting a thorough evaluation of the pipe. Once the sediment is removed from the pipe, the pipe will be re-surveyed with the video equipment and a plan to address the storm water system will be developed.
